REPORT OF THE 1912 INSPECTION OF THE PITTSBURGH TEST FENCE,

INCLUDING THE REPAINTING TESTS AND THE NEW TESTS.

HENRY A. GARDNER, Director

PAINT M'F'RS ASSOCIATION OF THE UNITED STATES PHILADELPHIA, PA.

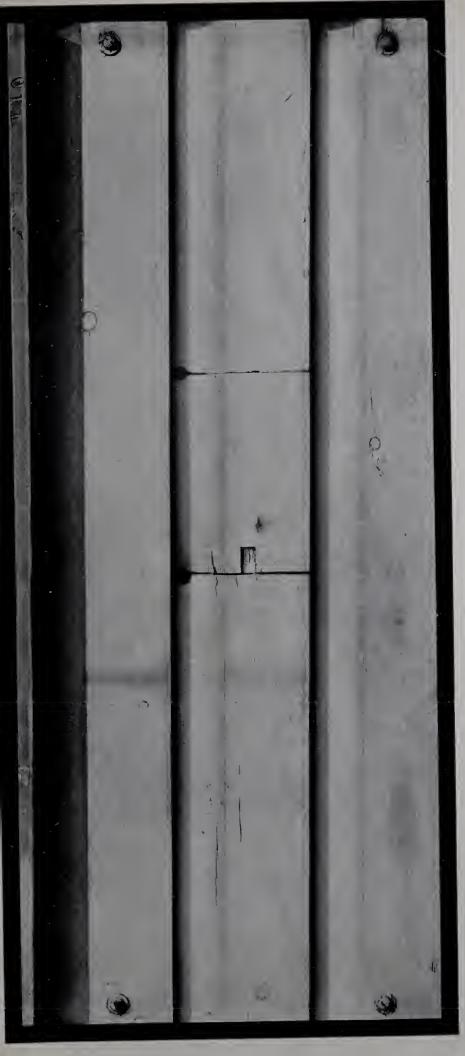
Test Panel No. 8

Results of Inspection. Aug. 29, 1912: Chalking: Considerable Checking: Slight Condition: Good Remarks: White surface 48.5% 48.5% 3.0%

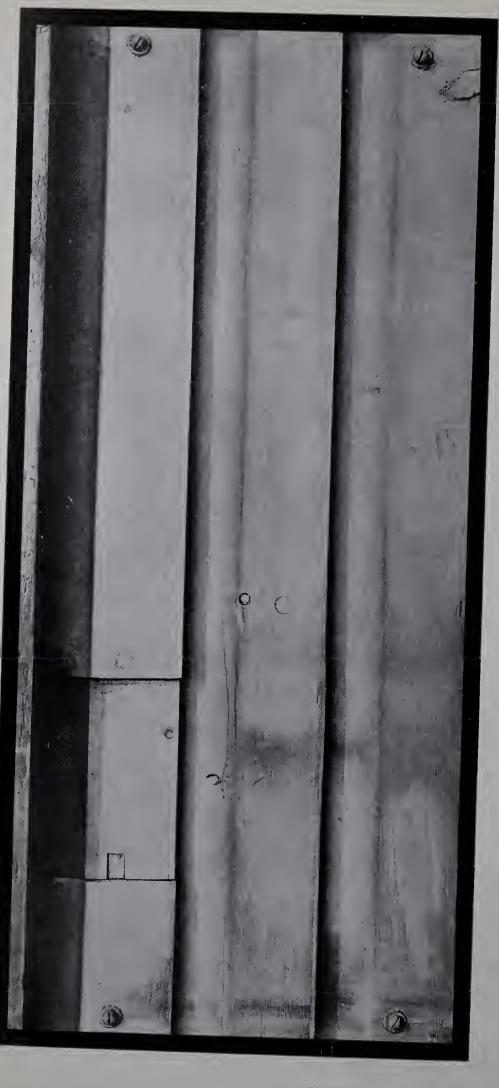
Formula No. 8

Results of Inspection, Aug. 29, 1912: Chalking: Heavy Checking: Slight Condition: Good Remarks: Medium white surface 38% 48% 14% Basic Carbonate-White Lead.
Zinc Oxide.....

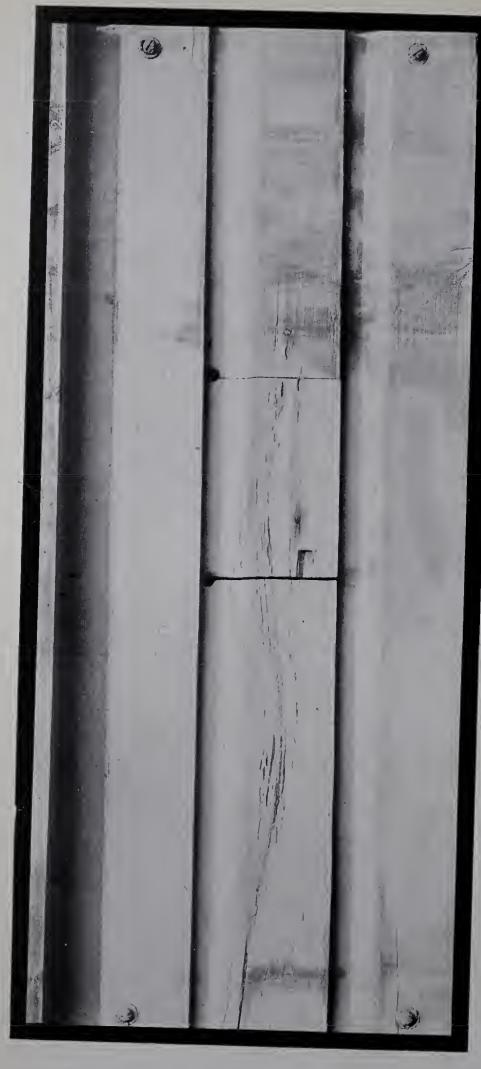
Test Panel No. 22

Results of Inspection, Aug. 29, 1912; Chalking: Medium Checking: None Condition: Fairly Good Remarks: White %0% 20%

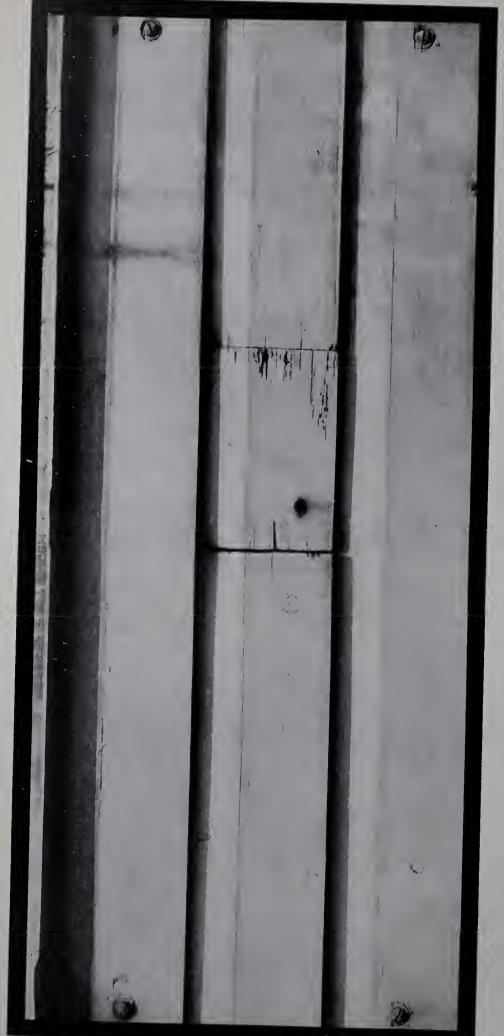
Results of Inspection, Aug. 29, 1912: Chalking: Medium Checking: None Condition: Very good Remarks: White surface 60 27% 37% 10%

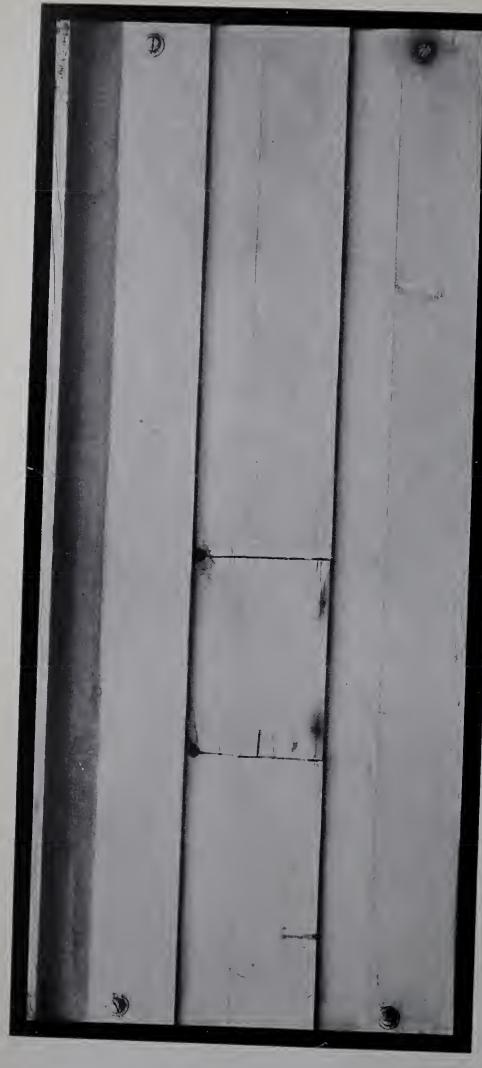
Test Panel No. 30

Results of Inspection, Aug. 29, 1912; Chalking: Medium Checking: Some lateral checking Condition: Fairly good Remarks; White surface 204 2088 10888 Basic Carbonate-White Lead......

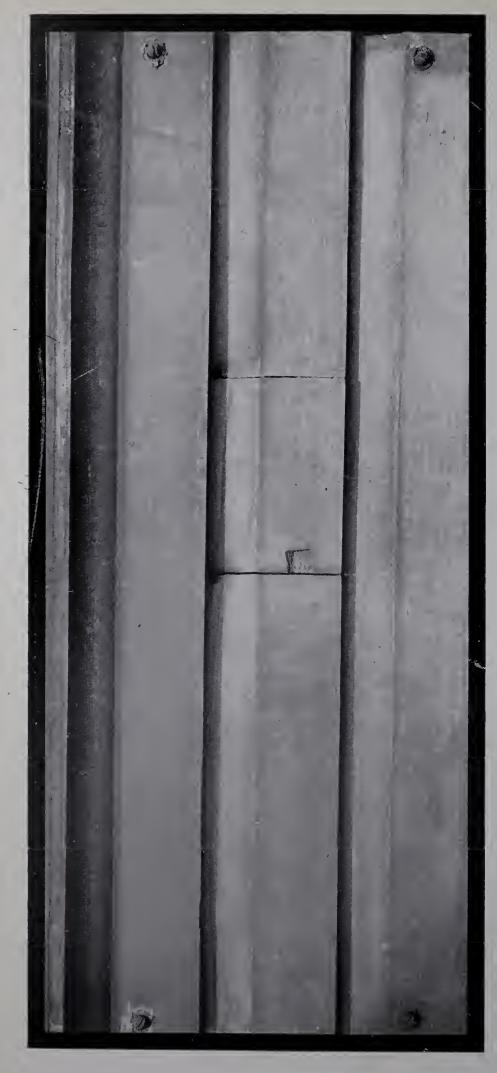
Test Panel No. 34

Results of Inspection, Aug. 29, 1912: Chalking: Medium Checking: Slight Condition: Good Remarks: White 404 408 888 44 888 Basic Carbonate-White Lead.....

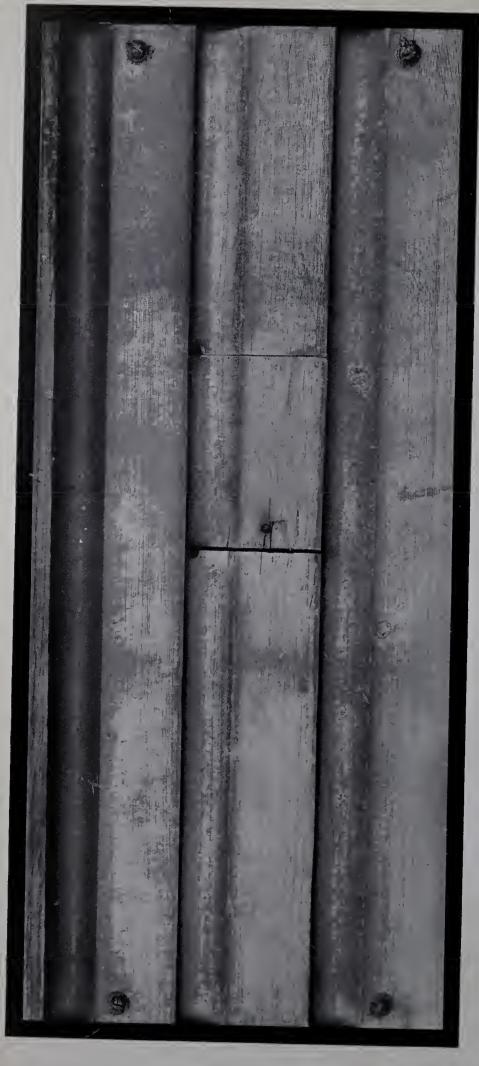
Formula No. 20 Test Panel No. 40

67.0% Results of 1

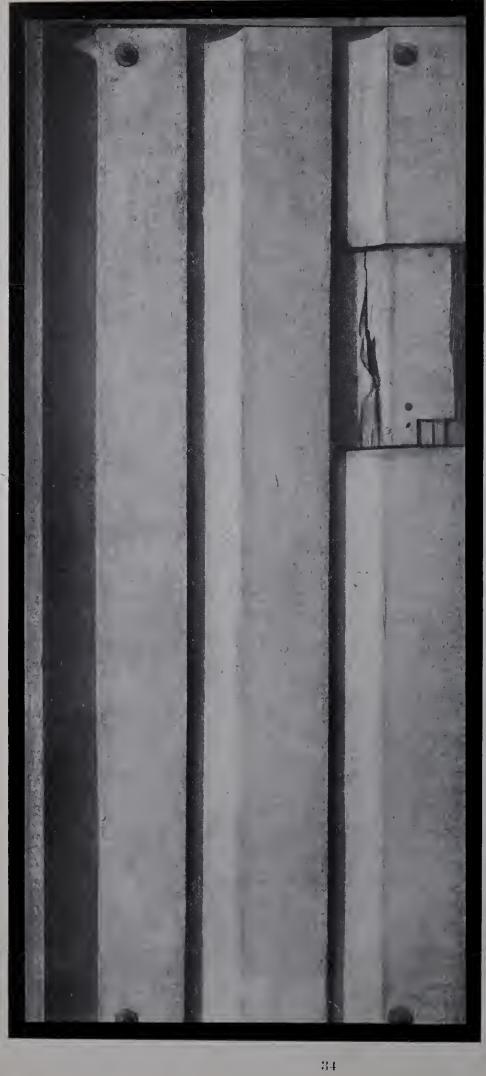
Test Panel No. 175

Results of Inspection, Aug. 29, 1912: Chalking: Medium Checking: Considerable Condition: Poor Remarks: Much darkened

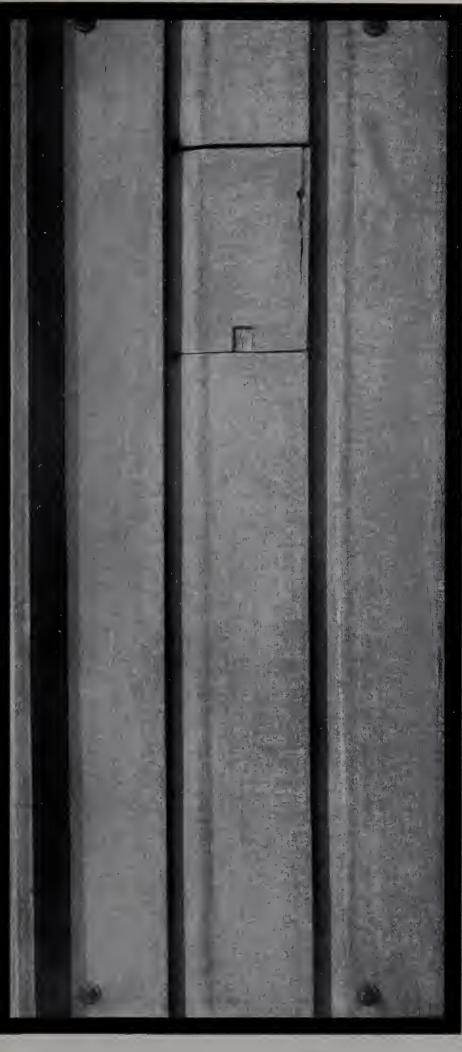
Test Panel No. 176

Results of Inspection, Aug. 29, 1912: Chalking: None Checking: Heavy alligatoring Condition: Poor Remarks: Darkened 100%

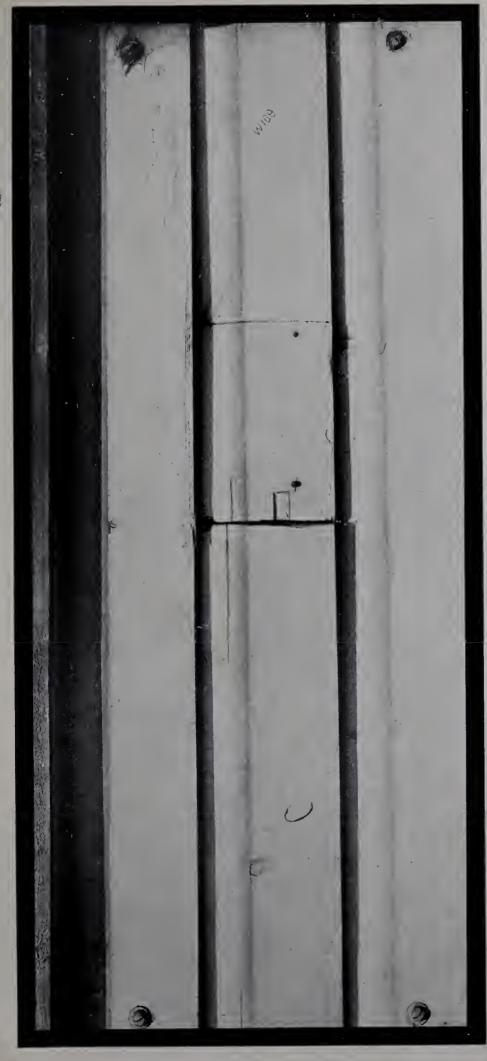
Test Panel No. 178

...... 100% Results of Inspection, Aug. 29, 1912;
Chalking: Heavy
Checking: None
Condition: Good
Remarks: White

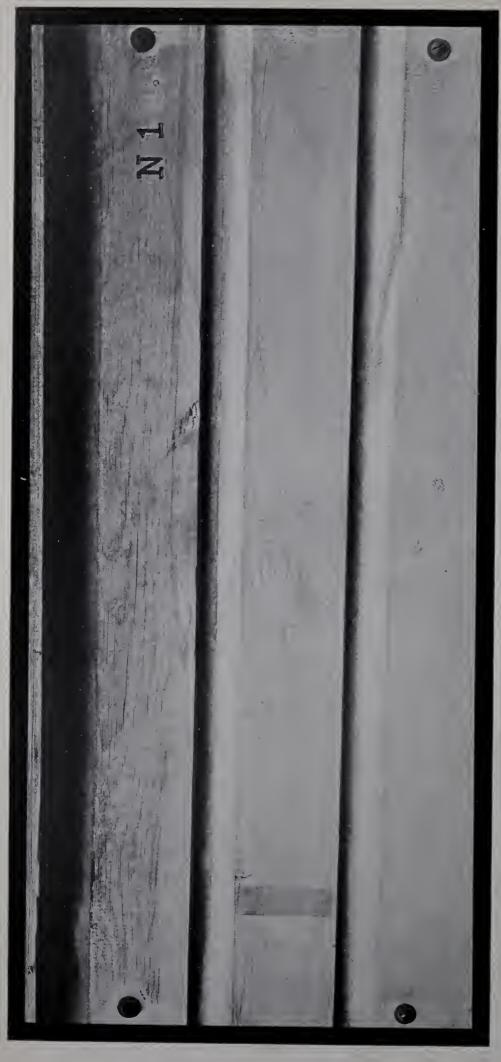
Test Panel No. 171

Results of Inspection, Aug. 29, 1912; Chalking: Very slight Checking: Considerable Condition: Poor Remarks; Scaling pronounced ... 100%

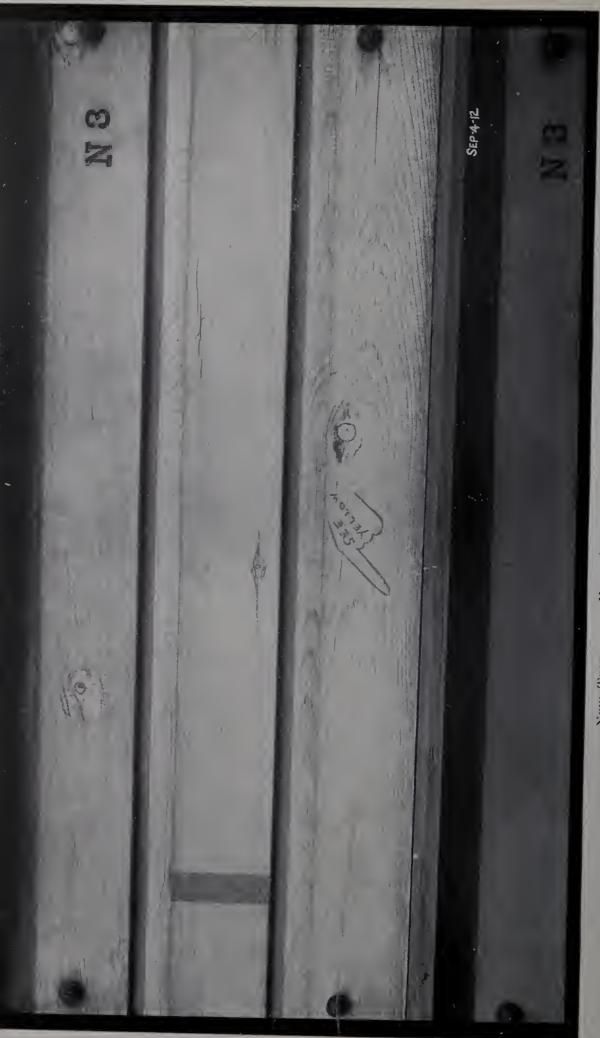
Test Panel No. 2

Results of Inspection, Aug. 29, 1912:	Chalking:	Checking:	General Condition: —	Remarks: Disintegrated
Basic Sulphate-White Lead45%	Lithopone 40%	Silica 15%		100%

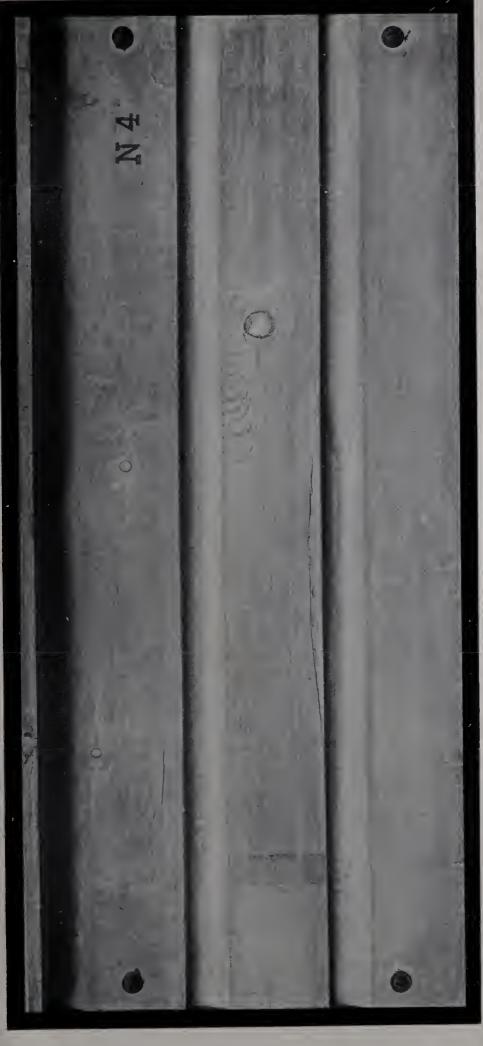
Results of Inspection, Aug. 29, 1912; Chalking: —— Checking: —— General Condition:—— Conarks: Disintegrated Test Panel No. 3 Formula No. 3 45% 10% 10% Zine Oxide.... NEW TESTS

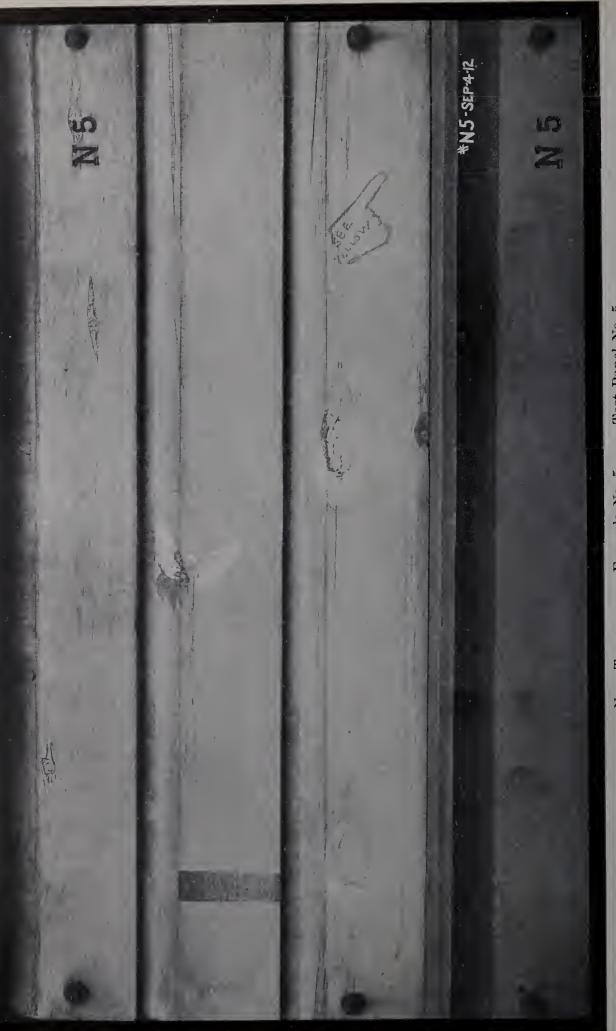
Test Panel No. 4

Results of Hispertion, Aug. 59, 1514.	Chalking:		General Condition:	Remarks: Disintegrated
Basic Sulphate-White Lead	Lithopone 45%	Calcium Carbonate		100%

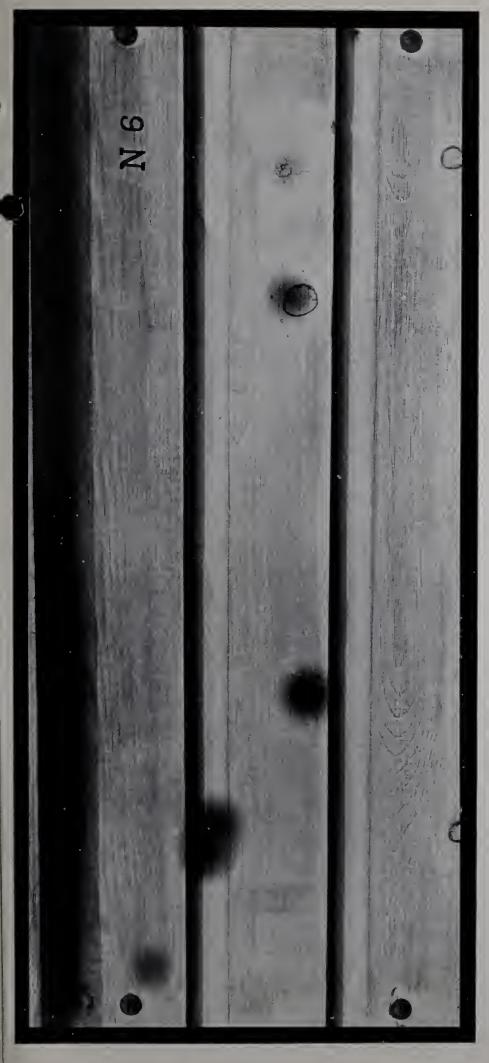
Results of Inspection, Aug. 29, 1912:
Chalking: ——
Checking: ——
General Condition: ——
Remarks: Disintegrated Test Panel No. 5 Formula No. 5 100% NEW TESTS Zine Oxide.....

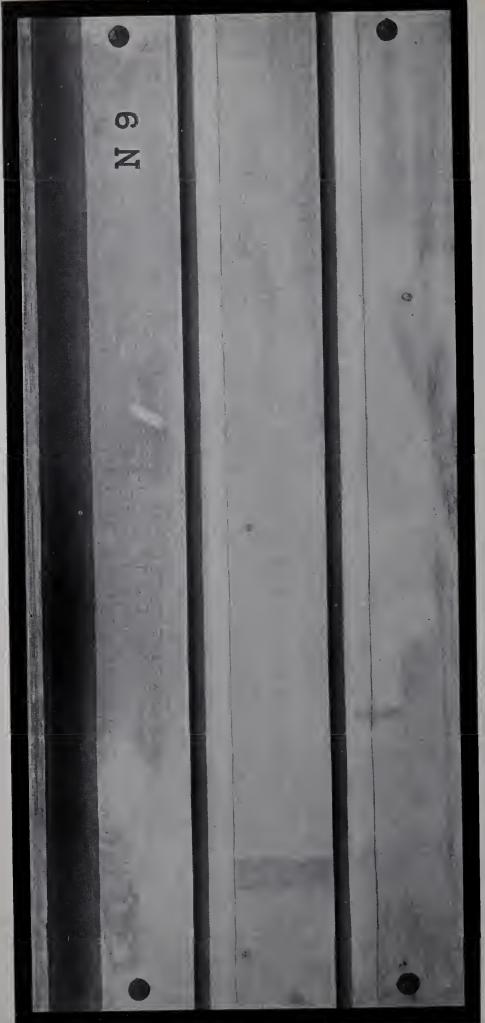
Test Panel No. 8

Results of Inspection, Aug. 29, 1912: Chalking: Heavy, scaled General Condition: Very poor Remarks: Darkened surface caused by lithopone and lead mixture Ashostine Lithopone Barytes Basic Sulphate-White Lead.....

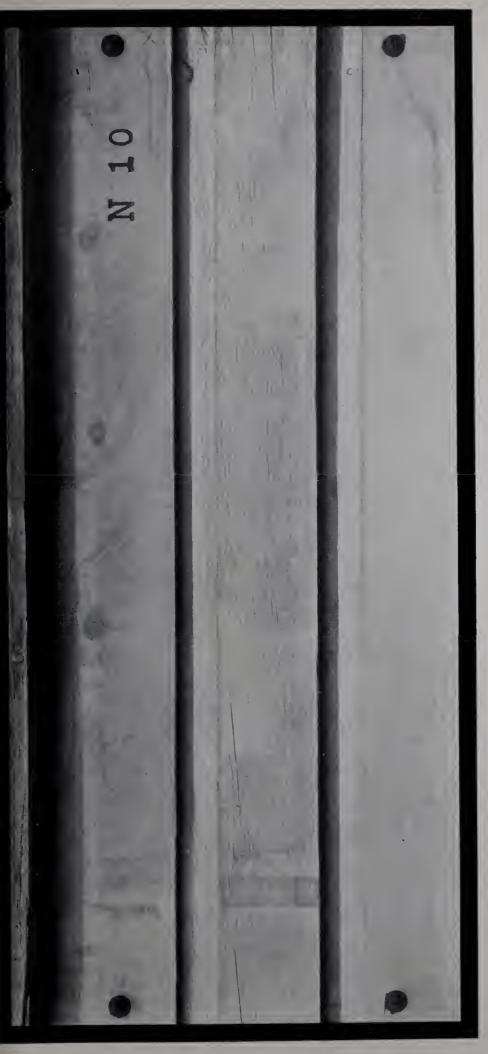
Test Panel No. 9

Results of Inspection, Aug. 29, 1912:
Chalking: Heavy
Checking: Heavy. scaled
General Condition: Very poor
Remarks: Darkened surface caused 100% Lithopone Basic Sulphate-White Lead.....
